## ***Valuation Report - Single Screw Mooring Barge ‘Regnum IV’***

On instructions from the Chichester Harbour Conservancy, Owner of the single screw mooring barge ‘**Regnum IV**’, I have undertaken walk through inspection ashore and on the basis of my findings have prepared a valuation of the vessel.

## NON-DESTRUCTIVE TEST REPORT

REPORT No. 114243/1021

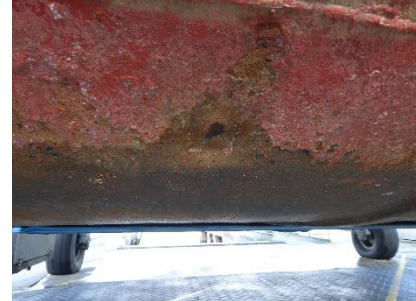
2. There is a dent in the bottom plating, to starboard, at the forward cut up; it is assumed the vessel hit the ground at some time in the past. Although not structurally affecting the hull at present the damaged area should, in my opinion, be removed and an insert plate fitted. Refer to the photograph to the right.

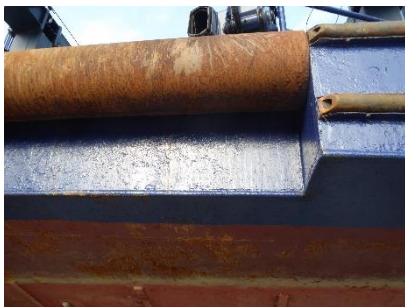
5. The bow roller is seized; the recommendation is for the roller to be removed, the bearings over-hauled and the roller replaced. Refer to the photograph to the left.

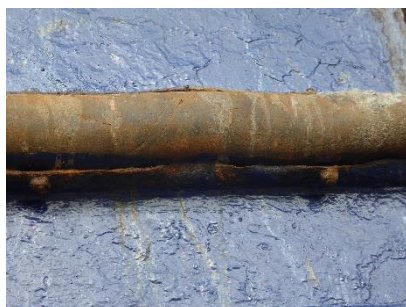
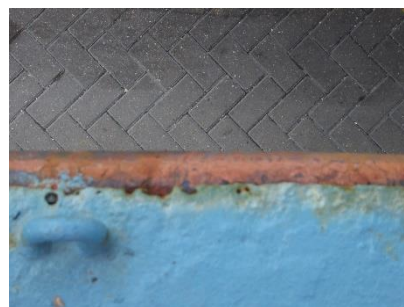
6. The ship side fendering and its supporting structure is in poor condition; in my opinion it will need to be completely removed, the condition of the plating behind examined and the bolting plates removed. Once the removal work is complete the various options for a replacement system will

need to be considered. Refer to the photographs below.

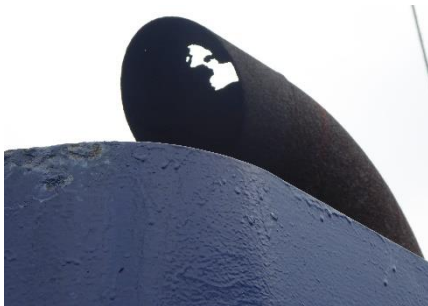
10. The wheelhouse is in structurally satisfactory condition although it could be worth considering blasting the exterior when the remainder of the vessel is blasted. There was a minor leak noted on one window. The main engine exhaust outlet is heavily corroded, see to the left, and will need replacement, stainless steel should be considered.

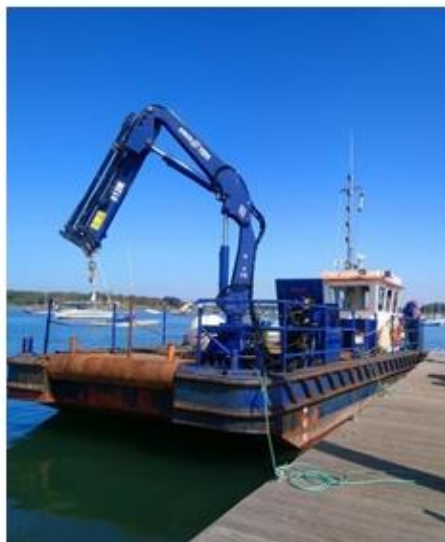
REGNUM IV Alongside at Chichester Harbour Conservancy Pontoon, Itchenor.

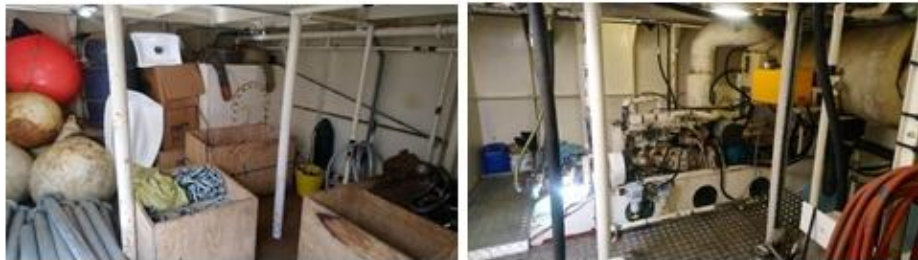
REGNUM IV Forward Hold and Engine Room (Stbd Side).

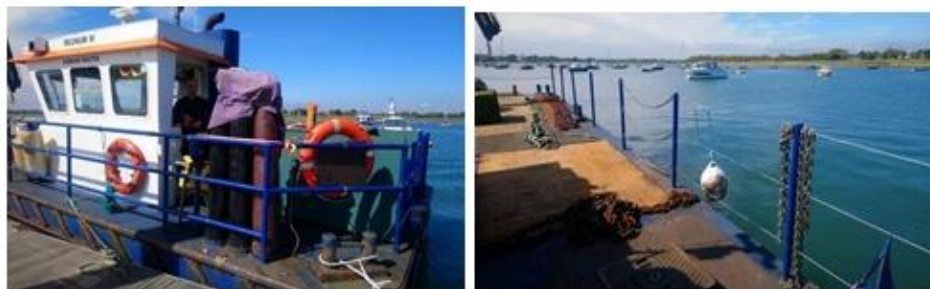
REGNUM IV from Port Aft and Stbd Side Guard Wires /Chains.
