A HISTORY OF EAST HEAD

CHICHESTER
HARBOUR
CONSERVANCY

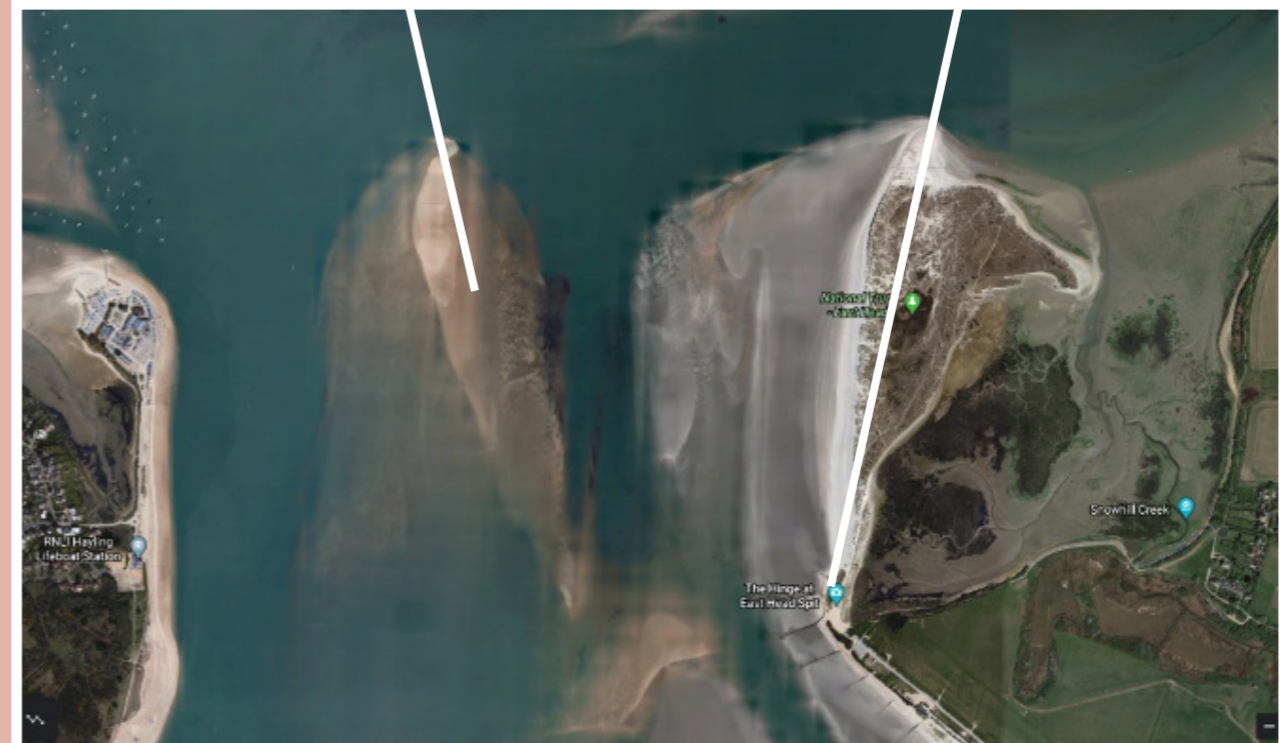
THE WINNER

THE HINGE

Aerial image of EH at Harbour entrance - Google Earth

There are other sources of sediment supply to the shore and dunes of East Head. The most important is the large sand bank located off its' western shore towards the entrance of the Harbour, known as 'The Winner'. The Winner has been created by shoaling waves approaching the Harbour from the south and southwest.

At low tide, a large expanse of The Winner is exposed. The surface sediment dries out and is then blown towards East Head by the prevailing onshore winds, providing a supply of sand to build up the sand dunes. In the sheltered area behind East Head, silt and clay have been deposited and a large area of saltmarsh has established.

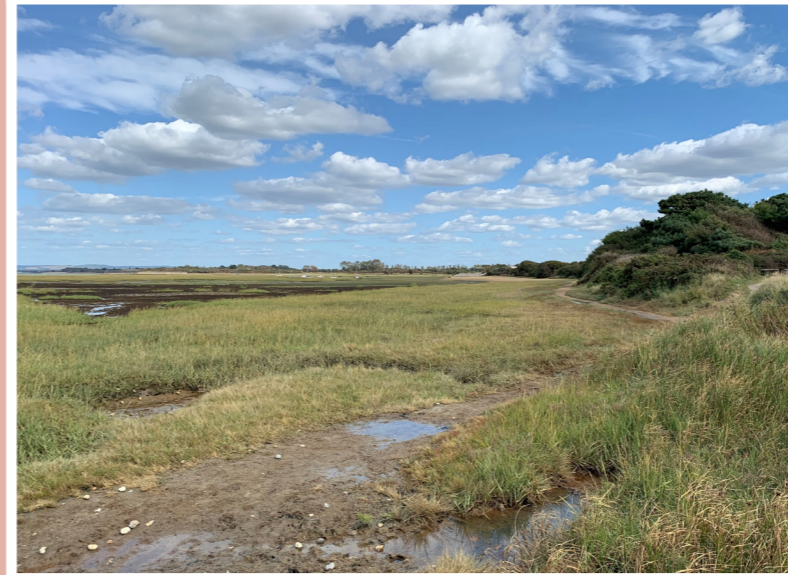
Saltmarsh behind East Head

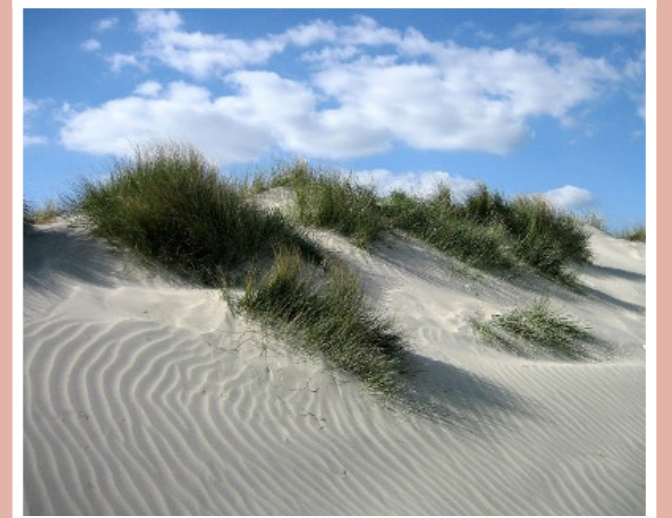
The sand dunes of East Head

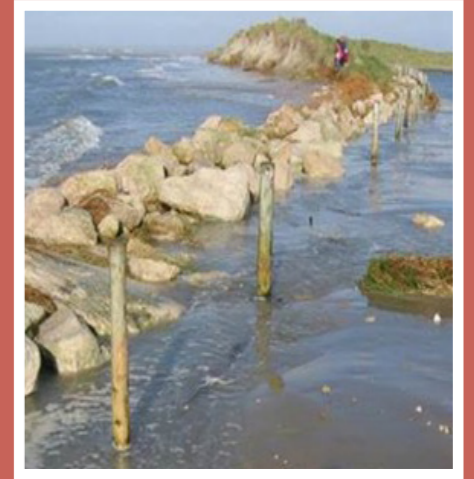
THE NEAR BREACH OF 2004

In October 2004, a combined storm and tidal surge over washed the Hinge and the neck, causing it to be narrowed further and flattened. Some of the eroded sand was pushed landwards and spilled across the saltmarsh behind. This dramatic event might have been a full breach if the rock berm had not been present as it kept the residual spine of the Hinge and neck in place.

The debate on the long-term coastal management strategy continued, but as an immediate, short-term response 13,000m³ of sand were recycled from the northern tip of East Head and brought back to rebuild the neck. Marram grass was planted to help stabilise the sand and encourage regeneration of the dunes at this location.

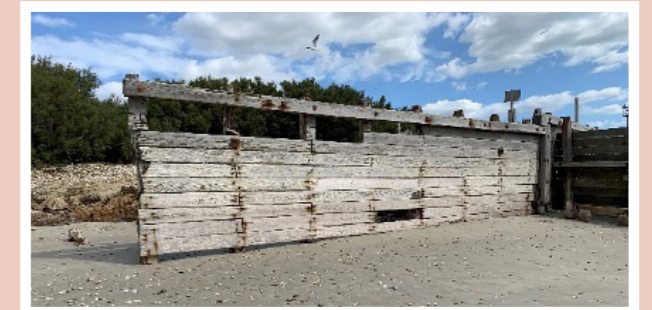
In 2009, the hinge and neck were recharged with 9000 tonnes of sand and shingle taken from the northern tip of East Head. This was carried out in preparation for the failure of the breastworks at the Hinge that were clearly deteriorating and to provide sufficient beach-width to allow natural re-alignment of the coastline.

Damaged gabions were removed between groynes 23 and 24 encouraging a more natural beach profile to develop. Planking was lowered on groyne 22 to allow the onward movement of shingle around the Hinge and raised on groyne 24 to retain shingle.

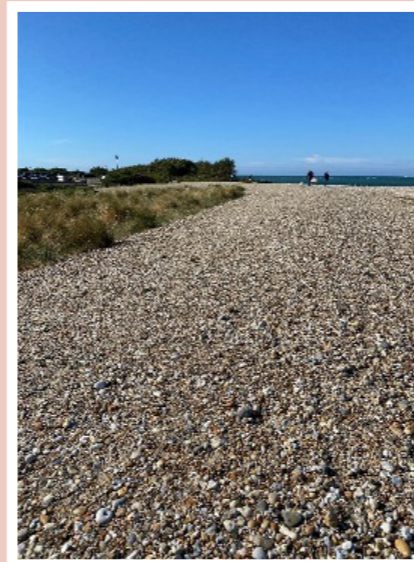
In 2015 the wooden breastworks at the Hinge were starting to fail and the land behind was beginning to erode. Plans were being made to commence the gradual removal of this breastwork, to allow a natural sloping beach to develop and for the coastline to re-align.

In January 2016, a further 2.5 tons of sand and shingle were moved to the Hinge forming a bund and raising the height of the ground level by 2metres. This was to ensure that the height of the land behind the breastwork was sufficient so that it would not be over washed by a tidal storm surge after this defence was removed.
