## ***Valuation Report - Single Screw Mooring Barge ‘Regnum IV’***

On instructions from the Chichester Harbour Conservancy, Owner of the single screw mooring barge ‘**Regnum IV**’, I have undertaken walk through inspection ashore and on the basis of my findings have prepared a valuation of the vessel.

## NON-DESTRUCTIVE TEST REPORT

REPORT No. 114243/1021

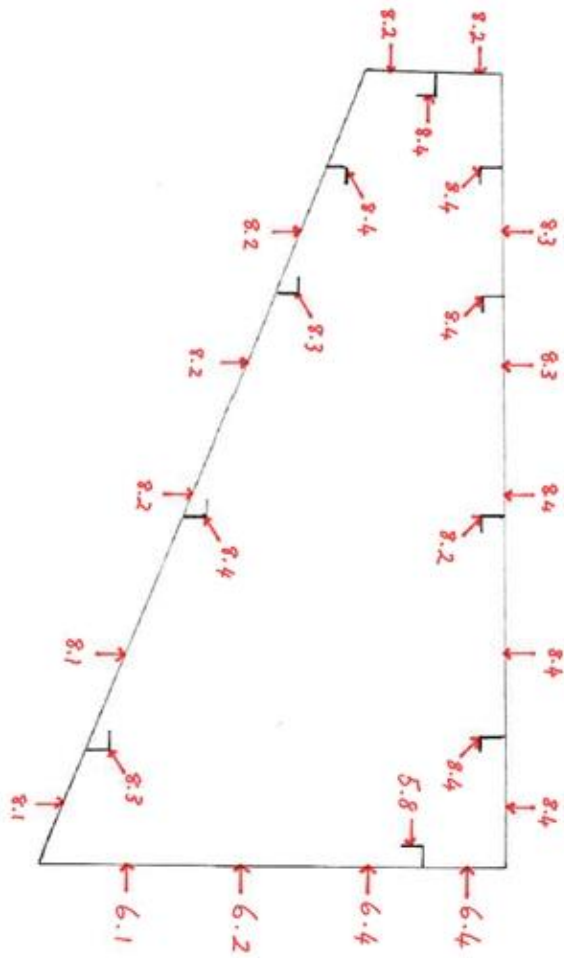
*Please see attached drawings with thickness values & locations marked in red*  
*All measurements recorded in millimetres*
